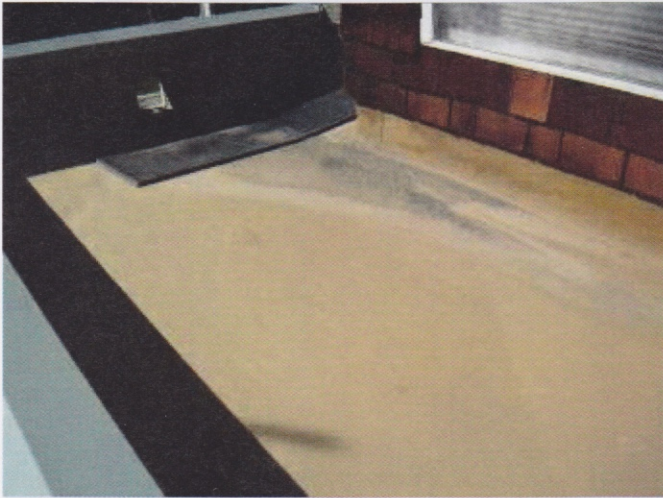
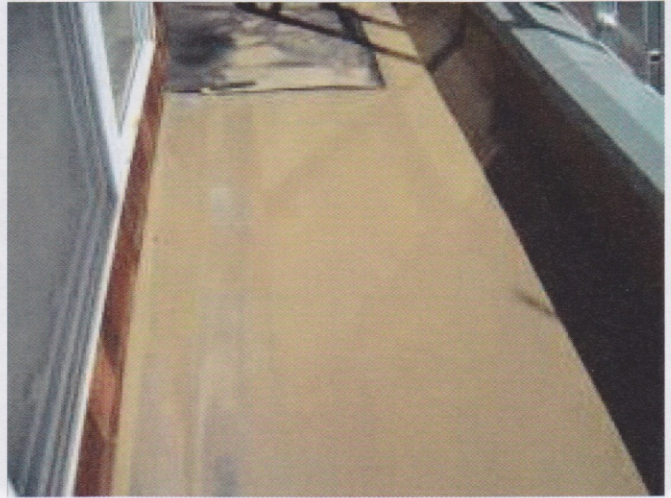
Comp #: 103 EPDM Flat Roof - Replace

It was reported that the roofing was replaced in 2005/2006. These roofs appeared to be in good condition. The average life for this type of roof ranges between 15 - 20 years, depending on quality of installation and roof materials. Remaining life based on age of the roof.

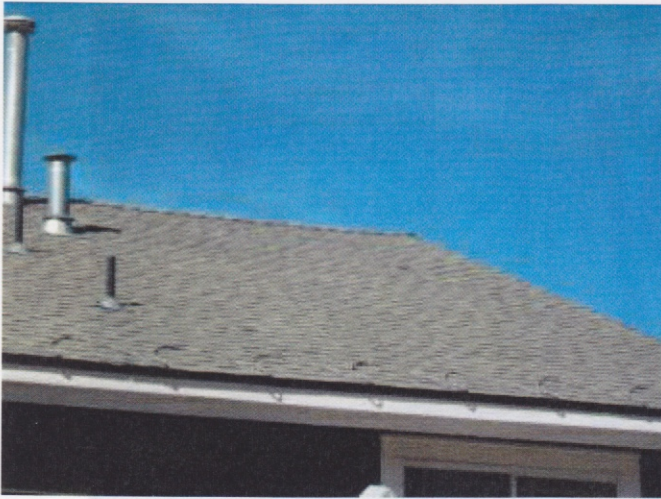
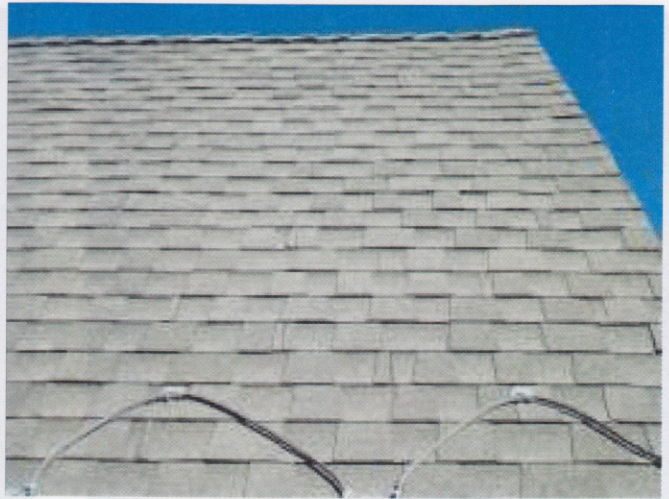
Comp #: 105 Comp Shingle Roof - Replace

It was reported that all building roofs were replaced at the same time during fiscal year 2005/2006. Even though this roof may be rated as a 25 year roof, a life expectancy of 18 - 20 years is expected in this environment. Due to the harsh winters and extensive freeze/thaw cycle over the useful life of the roof, we typically see Associations replacing roofs sooner than the manufacturer's suggested useful life. Remaining life based on age of the roof.

NOTE: The cost of re-sealing around the skylights is factored into the cost of re-roofing.

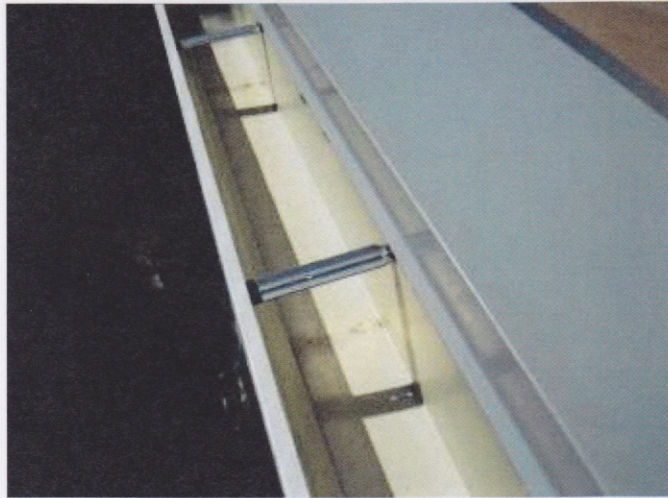
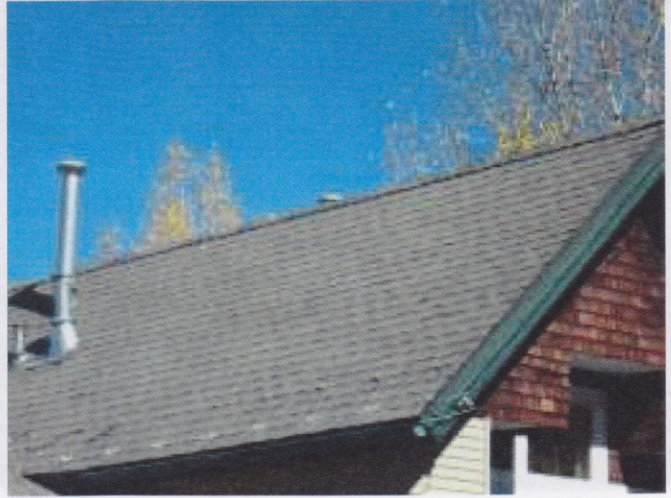
Comp #: 120 Gutters/Downspouts - Replace

It was reported that the rain gutters and downspouts were replaced in 2009 along with the heat tape. It is typical for debris, such as roof granules and dirt, to build up in the lines. When debris remains in the rain gutters, it will stay wet after rains and snow melt which will cause premature deterioration of the materials. Therefore, we recommend cleaning out the lines at least once a year as a maintenance expense to ensure full life expectancy. It is typical to replace rain gutters and downspouts at the same time as roof materials for best cost estimate. Therefore, Reserve to replace these lines every 20 years.

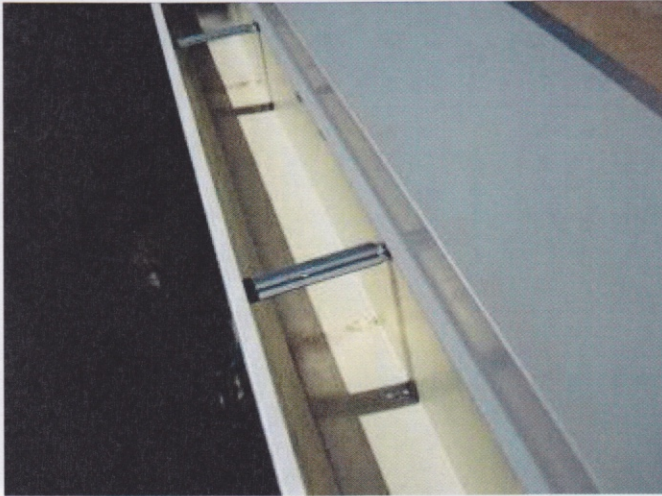
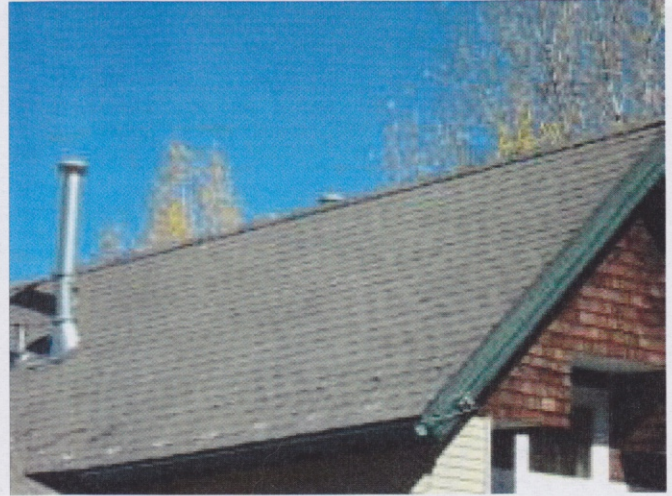
Comp #: 121 Heat Tape - Replace

Heat tape has been installed along edges of roof to prevent frost damage and ice damming to the roof shingles during winter months. It was reported that heat tape was installed shortly after the roofing replacement that occurred in 2005 and 2006. There were no problems noted or reported at the time of inspection. The typical life expectancy for this material is 7 - 10 years and replacement should also occur at the same time roofing and rain gutters are replaced. Therefore, the Useful Life and Remaining Useful Life have been adjusted to coordinate with the roofing and rain gutter replacement cycles.

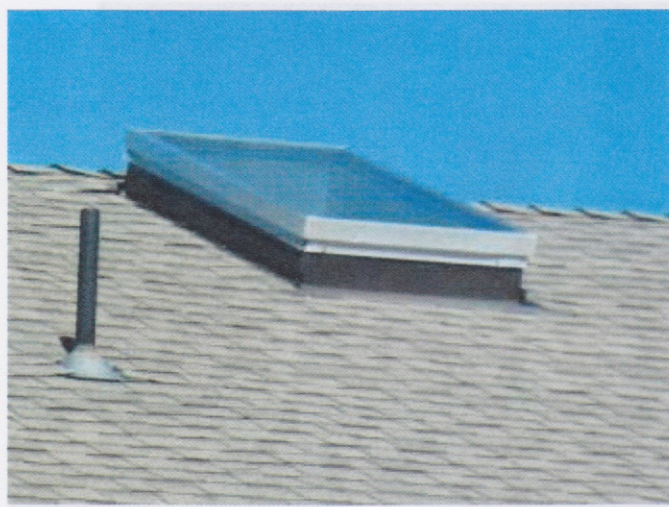
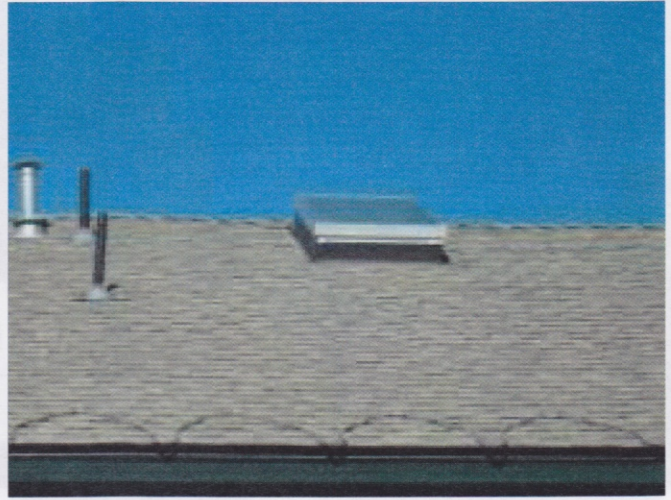
Comp #: 123 Skylights - Replace

According to the HOA Declarations, Article VII – Maintenance, Section 7.1c, " The Association shall maintain all of the exterior portions of the Townhome Building including without limitation the roof, siding, all exterior windows and doors". The skylights are considered a window but since it was reported that the individual townhome owners have taken on responsibility for window replacement, Reserve funding this component has been removed from this study at the request of the client. However, re-sealing the skylights should occur at the same time that the roofs are replaced and is therefore factored into the cost of roof replacement (see component #105).

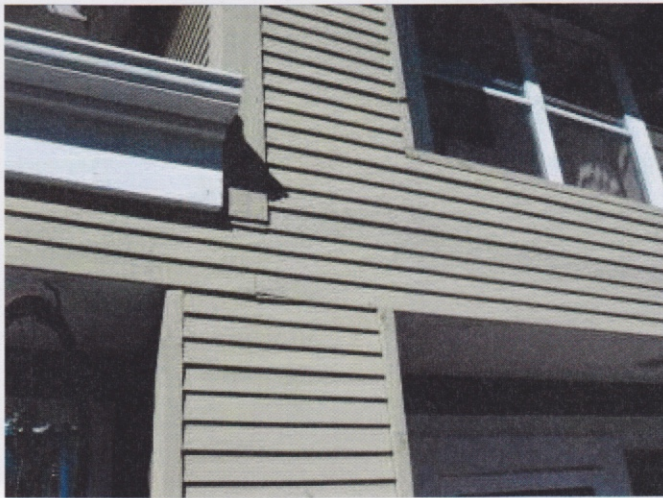
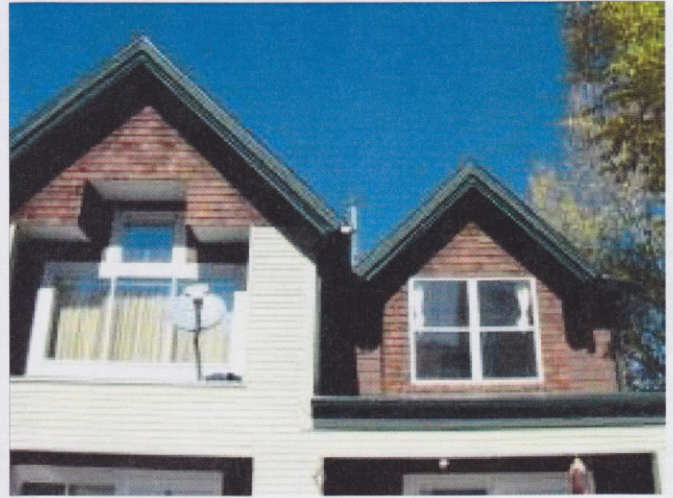
Comp #: 204 Building Ext Surfaces - Repaint

It was reported that the town homes were painted in 2009. The colors were still bright and vibrant at time of inspection. In order to maintain the appearance of the property, we suggest painting every 7 - 8 years, which is consistent with the reported painting cycle the Association has established. Remaining life is based on time since the last painting cycle.

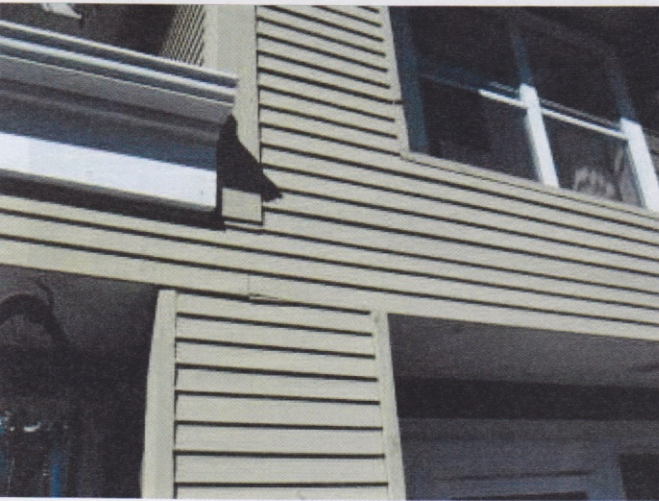
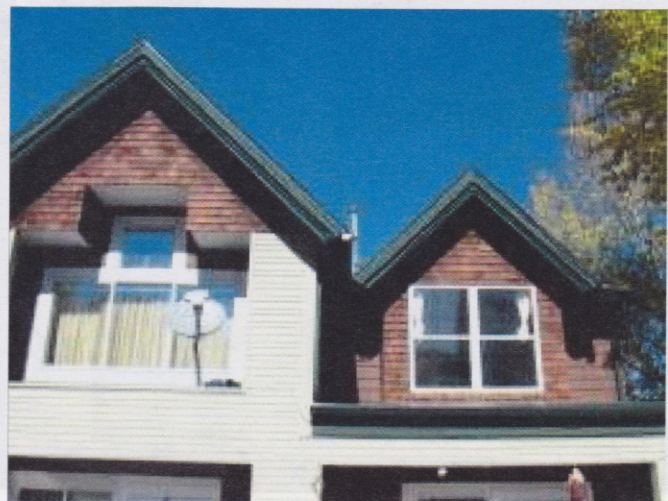
Comp #: 301 Hardboard Siding - Major Repairs

All surfaces were recently painted in 2009. However, there were no major repairs that occurred prior to painting. At time of initial inspection, there was evidence of damaged sections of siding materials that will eventually require repairs. Rather than Reserving for complete replacement (approximately \$300,000), we suggest establishing an allowance for major repairs every 8 years. We recommend coordinating these repairs prior to painting the buildings. As the property ages, it is possible the estimate for repairs will need to be increased in future Reserve Study updates. This material typically has an overall life expectancy of 25 - 30 years and can be extended with proper care and maintenance.

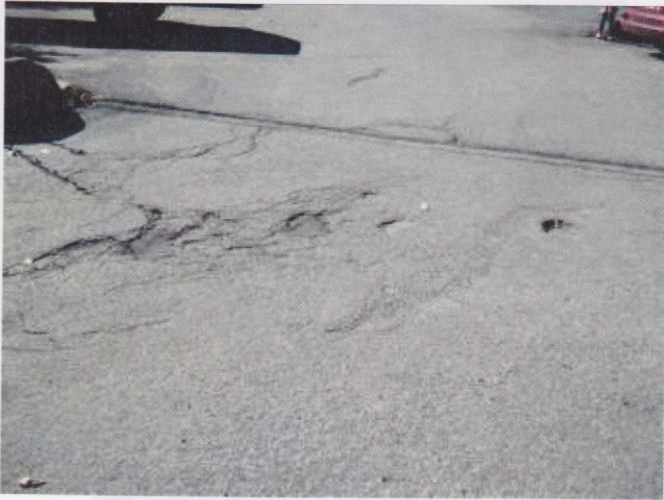
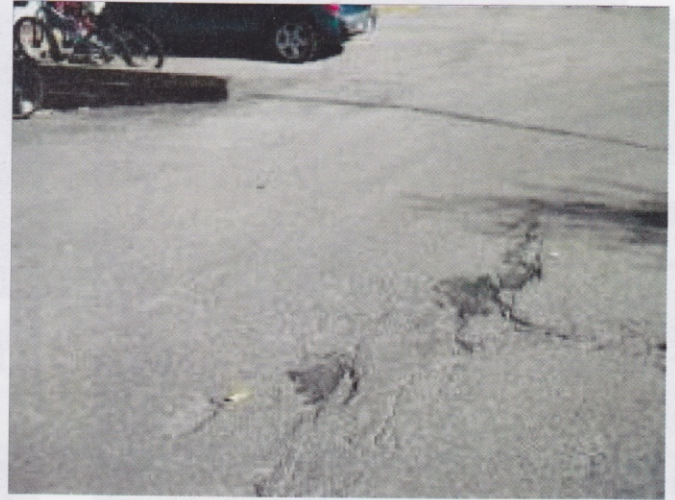
Comp #: 401 Asphalt - Overlay

It was reported that the asphalt is original. In general, the asphalt is in fair to poor condition with some potholes, cracking and other signs of age and deterioration observed at the time of inspection. These condition primarily exist in Grove Court. The average life expectancy for asphalt surfaces ranges between 20 - 27 years for surfaces that are maintained on a regular schedule. Maintenance includes crack fill and repairing small potholes annually as an operating expense. In addition, in this environment, asphalt should be seal coated every 2 -3 years, depending on the level of traffic and snow removing techniques. Remaining life based on observed conditions.

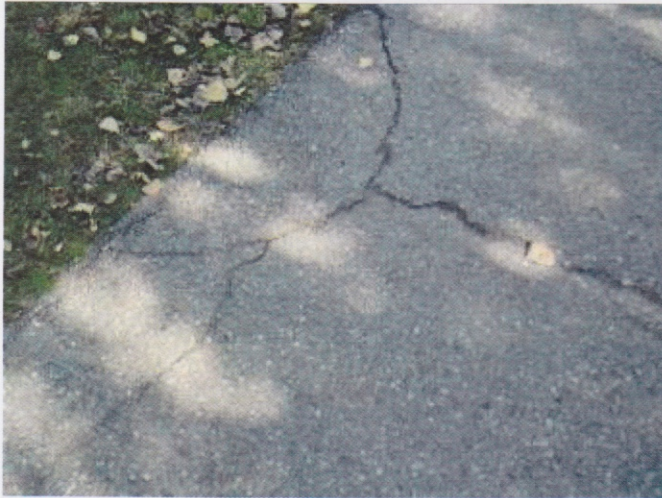
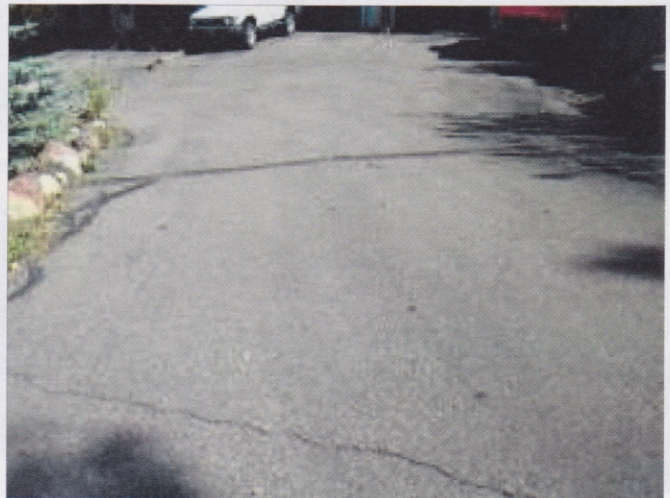
Comp #: 402 Asphalt - Seal Coat/crack fill

Surface is dry with some minor cracking noted throughout the community. Based on the observed conditions, it does not appear these surfaces have been seal coated in many years. It is important to maintain a proper seal cycle to protect the integrity of the asphalt and prevent extensive cracking, development of potholes, and loss of emulsion, which will lead to advanced deterioration. Depending on the type of snow removal techniques and the level of traffic, we suggest seal coating every 2 - 3 years. In between seal cycles, the asphalt should be inspected and any cracking that develops should be filled, along with any minor repairs to prolong the life of the surface.

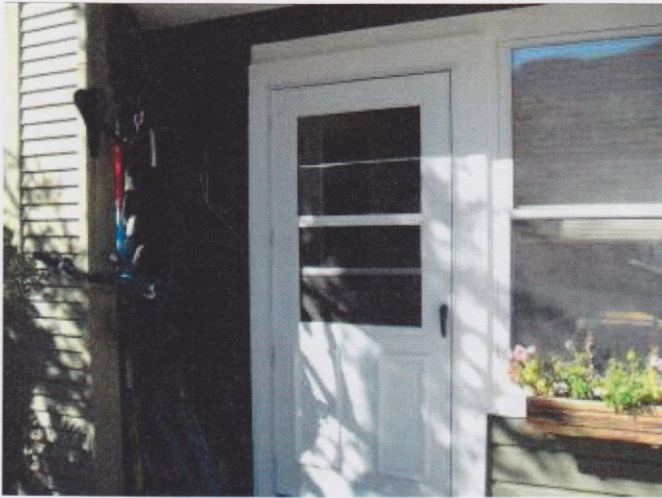
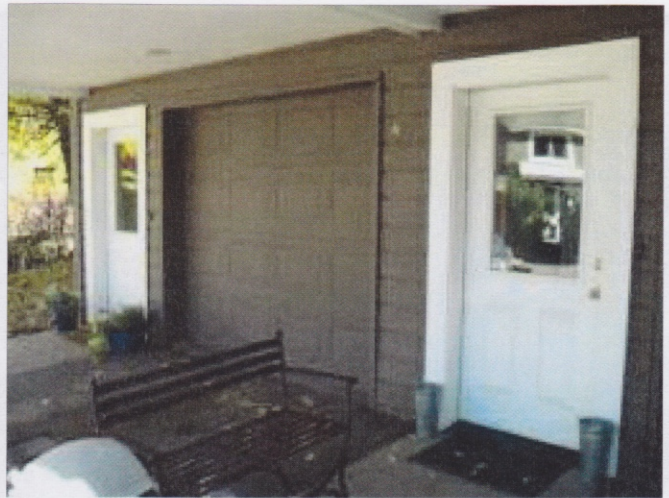
Comp #: 501 Front Doors - Replace

All doors appeared to be in good to fair condition with no problems noted at the time of inspection. The average replacement cycle for exterior doors ranges between 25 - 30 years under normal conditions. These doors are exposed to the elements, so a shorter life is possible. Remaining life is based on age of the community.

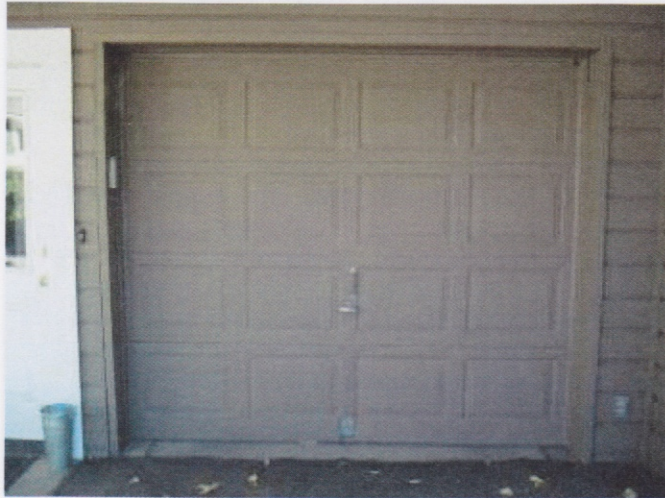
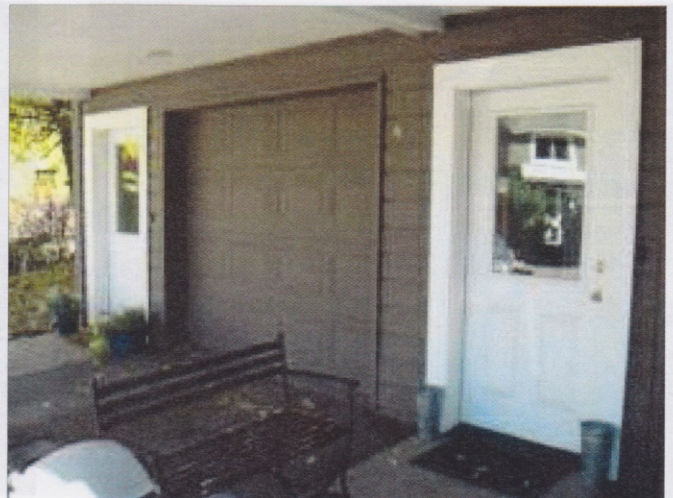
Comp #: 502 Garage Doors - Replace

No major problems observed with the garage doors at the time of inspection. It was reported by the client that the garage doors "not part of the Declarations" and are the responsibility of the unit owners for this building. At the request of the client, Reserve funding has been removed from report.

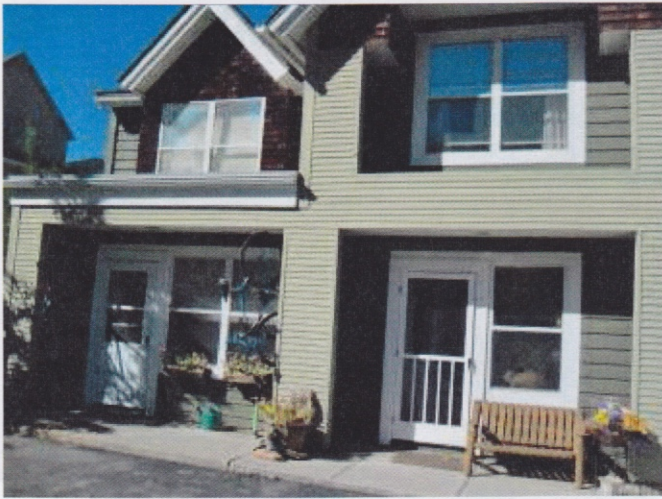
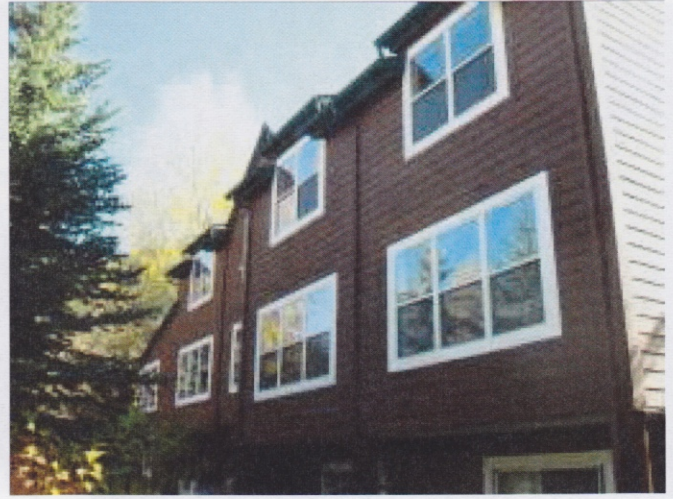
Comp #: 506 Windows - Replace

According to the HOA Declarations, Article VII – Maintenance, Section 7.1c, “ The Association shall maintain all of the exterior portions of the Townhome Building including without limitation the roof, siding, all exterior windows and doors”. However, it was reported by the client that the individual owners have taken on the responsibility of replacing their own glass in the windows. Therefore, at the request of the client, Reserve funding has been removed from the study. If the Association changes direction on this item and decides to take on window replacement, Reserve funding can be added in future updates.

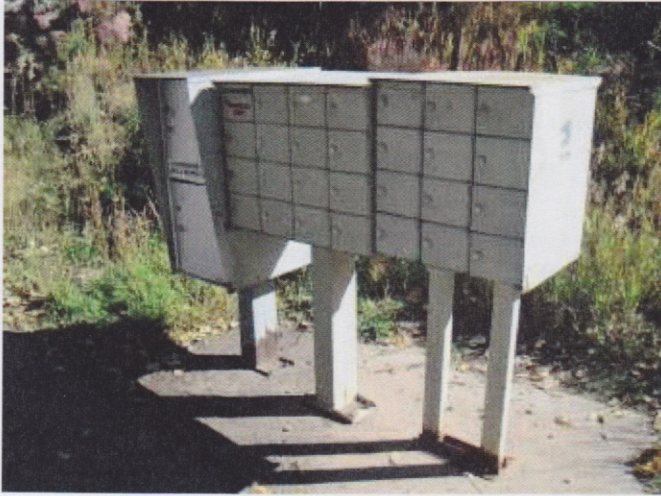
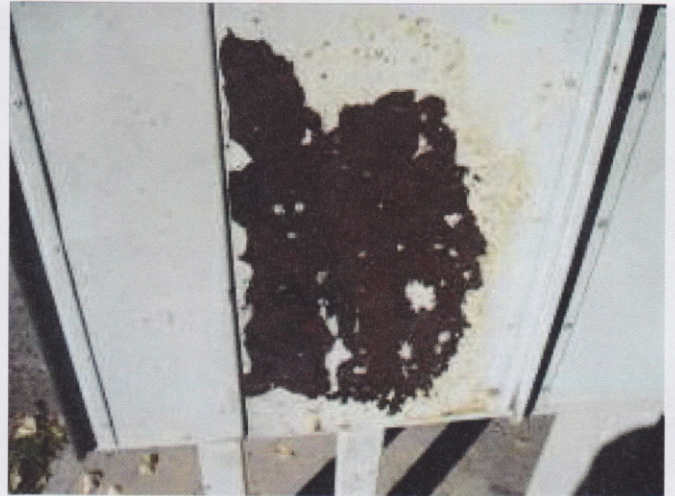
Comp #: 803 Mailboxes - Replace

Mailbox stations are rusting both at the base where they are anchored into the concrete pad and on the CBU's themselves. According to several manufacturers, the typical life expectancy for this type of mailbox is 15 - 20 years in this environment. Remaining life is based on observed condition of all units.

NOTE - Client reported that they have received estimates of approximately \$1500 plus installation, to replace the mailboxes.

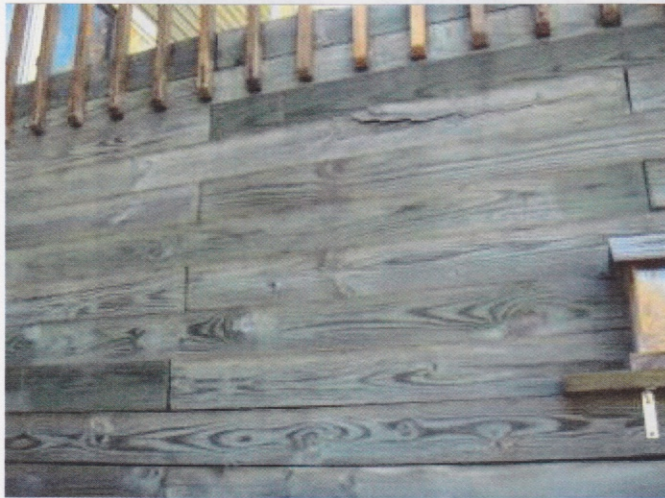
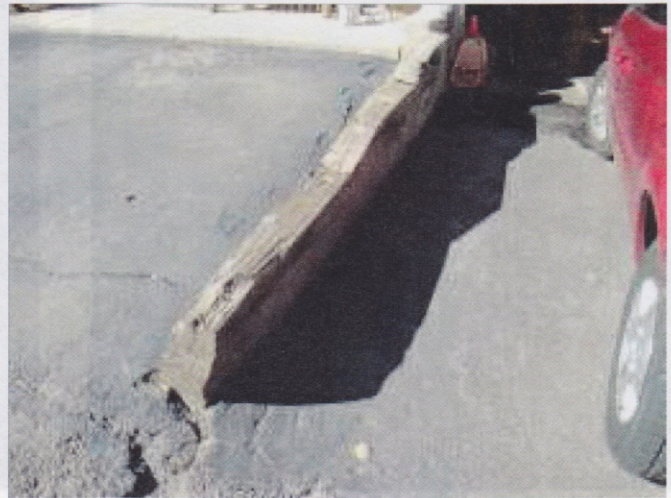
Comp #: 1011 Retaining Wall - Replace

Landscape timbers are in good to fair condition with some signs of leaning on the parking lot walls. Generally, in most conditions, these walls have an overall life expectancy of 20 - 25 years. However, with periodic repairs, the life of the wall can be extended. We suggest establishing a Reserve allowance for periodic major repairs and partial replacements (to approximately 20% of total area or 110 GSF) as opposed to complete replacement all at the same time. Remaining life based on observed conditions and to replace a portion of the parking lot walls with the next asphalt cycle.

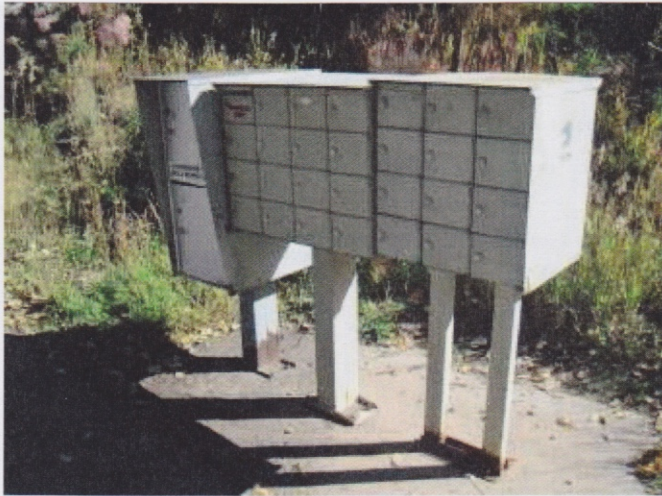
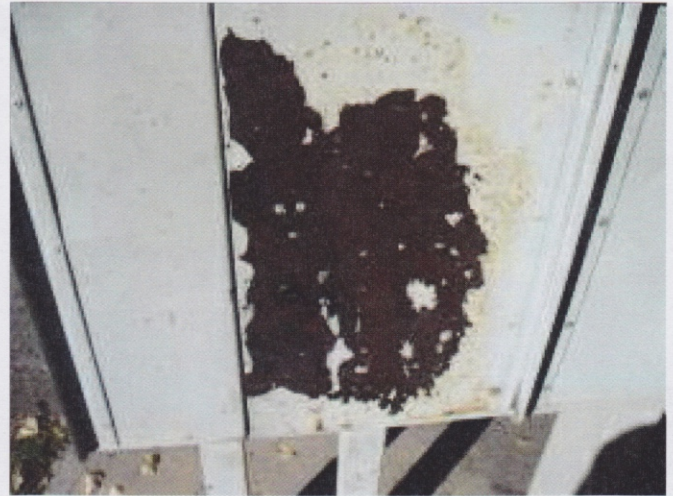
Comp #: 803 Mailboxes - Replace

Mailbox stations are rusting both at the base where they are anchored into the concrete pad and on the CBU's themselves. According to several manufacturers, the typical life expectancy for this type of mailbox is 15 - 20 years in this environment. Remaining life is based on observed condition of all units.

NOTE - Client reported that they have received estimates of approximately \$1500 plus installation, to replace the mailboxes.

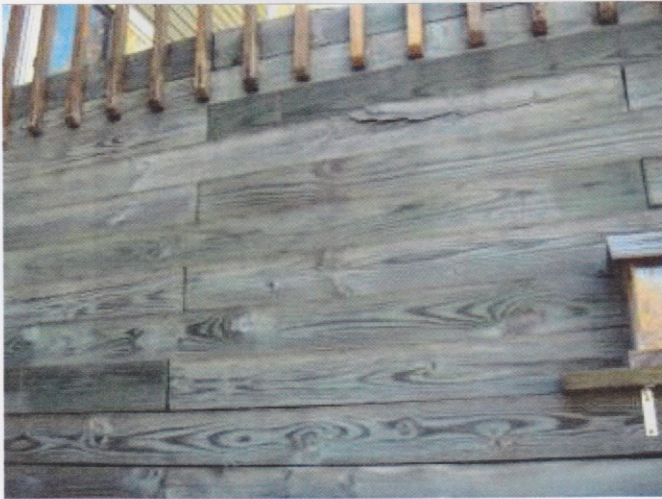
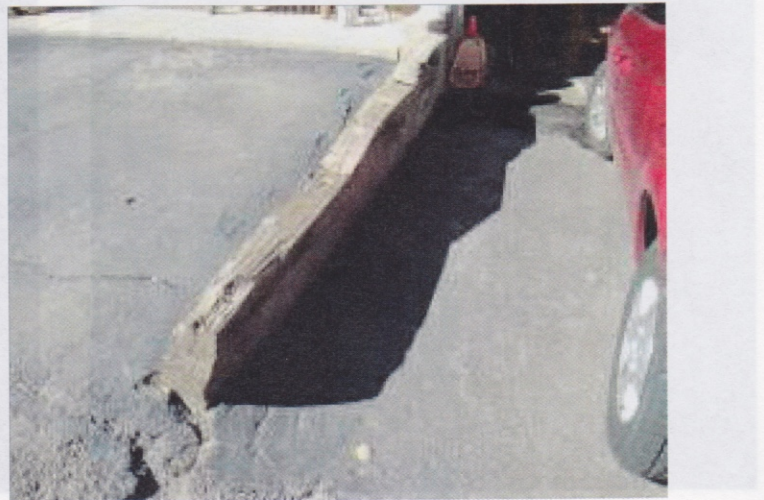
Comp #: 1011 Retaining Wall - Replace

Landscape timbers are in good to fair condition with some signs of leaning on the parking lot walls. Generally, in most conditions, these walls have an overall life expectancy of 20 - 25 years. However, with periodic repairs, the life of the wall can be extended. We suggest establishing a Reserve allowance for periodic major repairs and partial replacements (to approximately 20% of total area or 110 GSF) as opposed to complete replacement all at the same time. Remaining life based on observed conditions and to replace a portion of the parking lot walls with the next asphalt cycle.

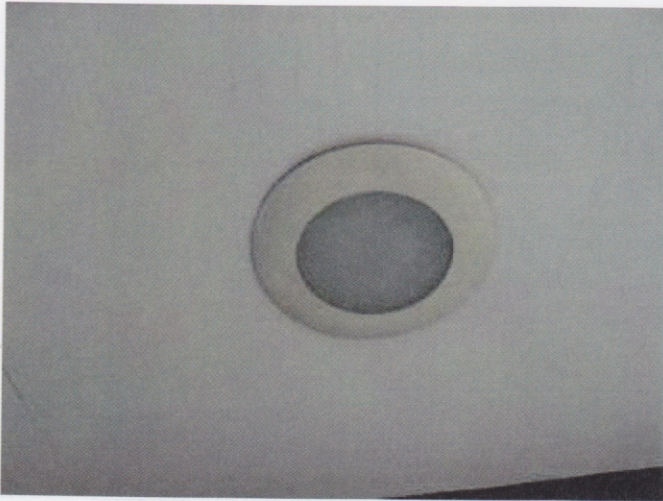
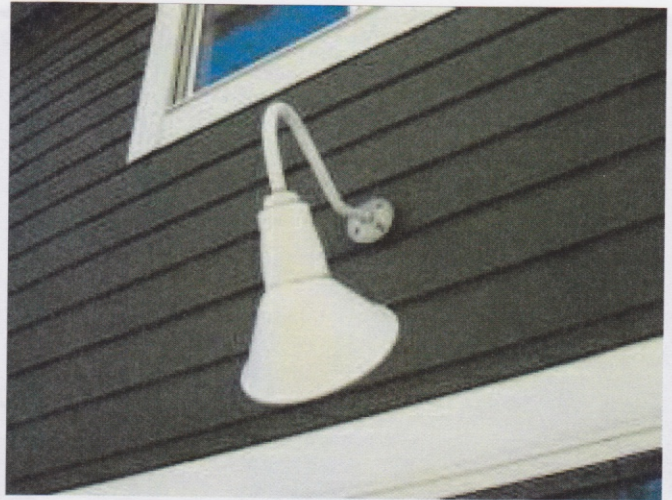
Comp #: 1602 Exterior Lights - Replace

No unusual conditions were observed or reported at time of inspection. While replacement can occur on an as needed basis, it is our opinion and recommendation to replace all lights at the same time every 15 - 20 years to maintain a consistent appearance throughout the property. In addition, by replacing multiple fixtures, the association will be able to obtain a quantity discount for the fixtures. Estimated replacement cost is for surface mounted decorative lights only and includes labor for installation. Recessed can lights should be repaired on an as needed basis. Remaining life has been extended based on observed conditions.
